Transport
Canada

TP 185E
Issue 3/2013

AVIATION SAFETY LETTER

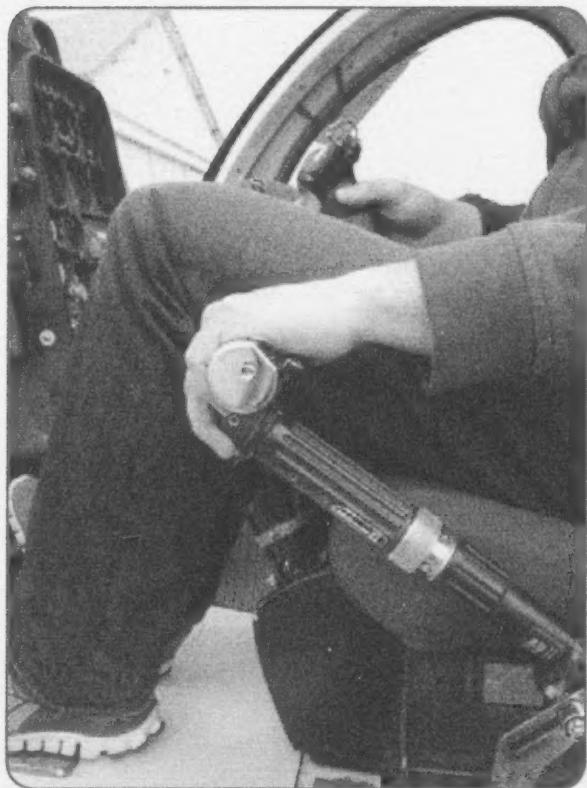
The second event happened in Alaska, where the pilot, with his hand in the same position, was hovering a Bell 205 and long lining. He pressed on the governor switch without knowing and landed safely with low rotor speed. After landing and with the helicopter still running, he came to the conclusion that he had inadvertently "beeped" the governor down.

Wrong position (on top of the governor beep switch)

As a result, our operator issued a bulletin making it company policy that pilots should never fly with their hand over the end of the collective. Our operator also announced additional training sequences on reduced power setting flight, low rotor rpm recognition and recovery, and the use of the governor range in order to show that the aircraft will still fly at the low end of the range.

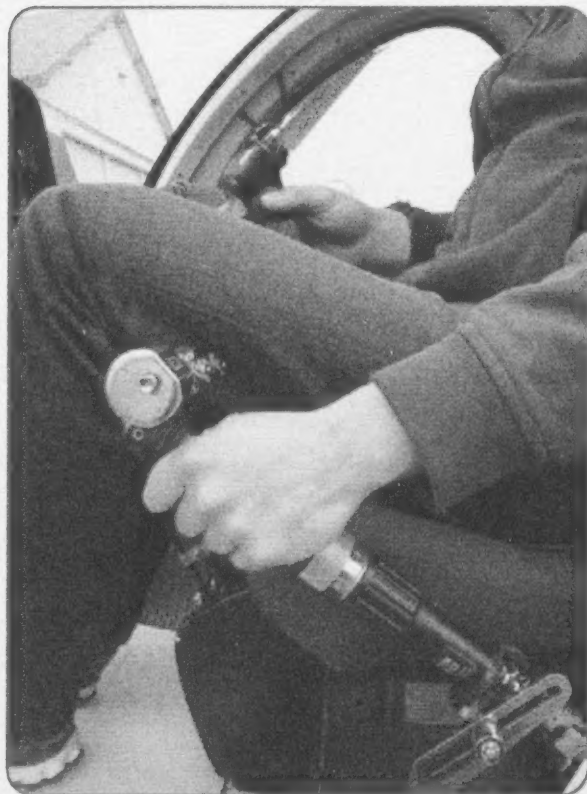
Right position

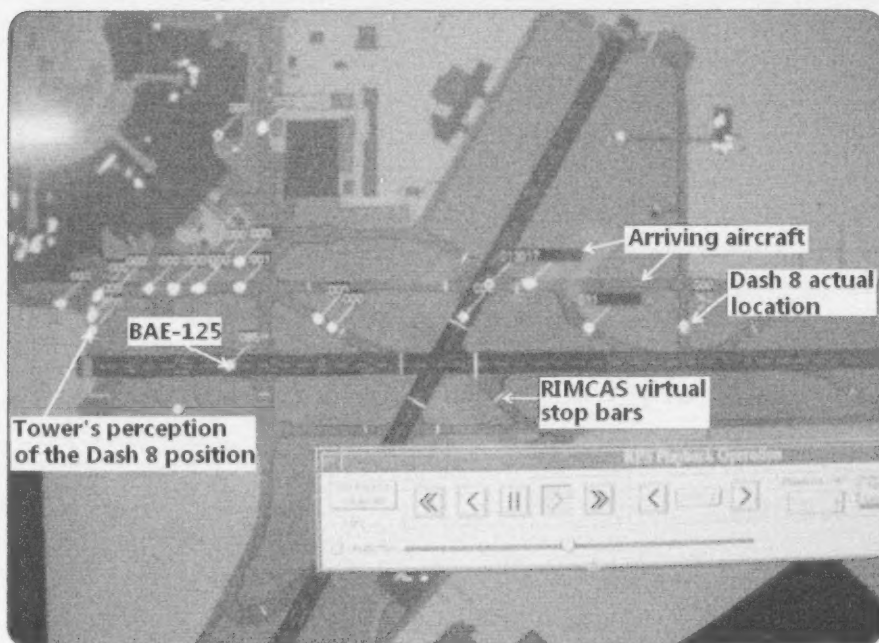
Airport Surface Detection Equipment (ASDE) display at 0943:49

The controller believed the Dash 8 to be at the threshold of Runway 16 (Taxiway C8), and the flight crew believed the controller knew they were at Taxiway U. It is likely that, as a result of the unexpected clearance of two flights between arriving flights, the flight crew of the Dash 8 felt rushed to get into position and simultaneously unsettled by their takeoff clearance that appeared to be sequenced much more quickly than previous departures. The assimilation of the departure heading instruction, the completion of the before takeoff check list, and the concern about a possible aircraft departing from the threshold all contributed to a high workload for the flight crew of the Dash 8. This would have resulted in little reserve to figure out that ATC believed them to be at Taxiway C8, as opposed to Taxiway U.

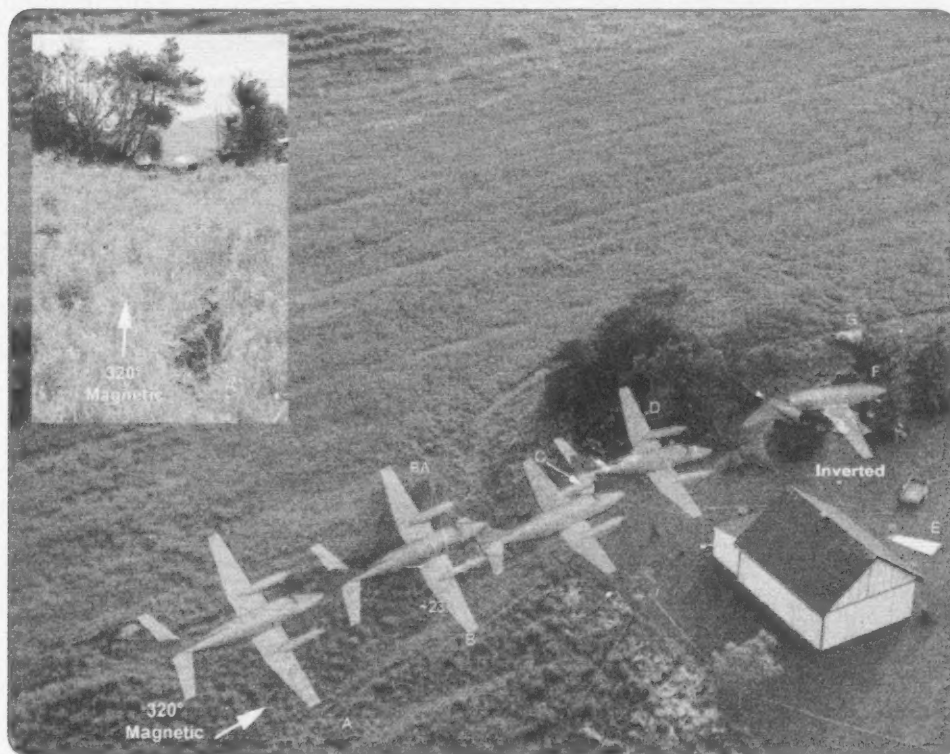
Illustration of impact sequence

2. The right engine experienced a problem in flight that led to a substantial loss of thrust.
 3. The right propeller was not feathered; therefore, the rate of climb was compromised by excessive drag.

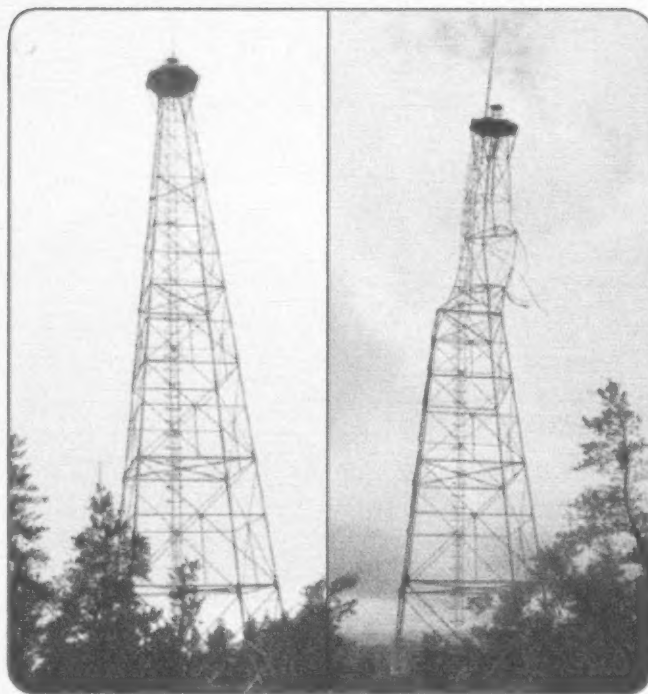
Side-by-side photos of the tower pre-and post-impact of a frontal impact with significant velocity. The global positioning system (GPS) data did not indicate any sudden manoeuvring. The velocity and course appeared constant, implying the pilot did not see the tower with enough time to react prior to impact, likely because the tower was obscured by the weather or blended into the overcast conditions.

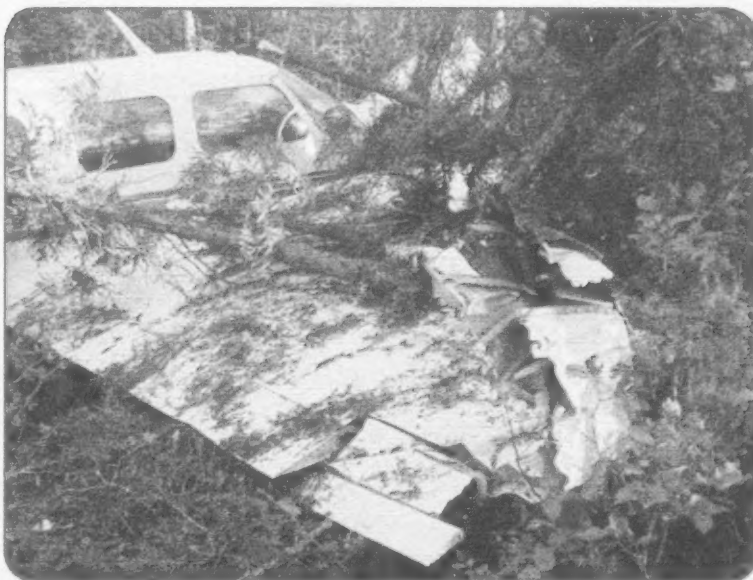
The initiating event of the occurrence was a magneto failure in the left engine. This failure was the result of the loss of retention of the bushing in the distributor block of the left magneto. The subsequent misalignment of the distributor rotor caused the rotor to fall out of synchronization with the engine. This caused the left engine to run rough, backfire and lose power. The clean, shot-blasted appearance of the piston crowns indicates that the rough running and back firing likely released combustion products that contaminated spark plugs of both magneto systems. It could not be determined whether the engine would have been capable of producing significant power running on the right magneto alone.

1. The left magneto distributor rotor gear teeth uncoupled from the input pinion gear, placing the distributor rotor out of time with the engine. As a result, the left engine began to run rough, backfire and lose power.
2. The pilot shut down the left engine, but did not immediately adjust the power on the operating engine. Airspeed then decreased to a point where the addition

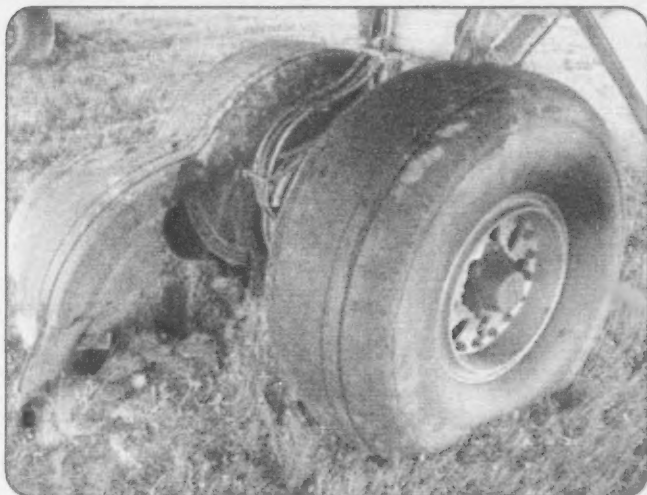
The TSB calculated the wear, based on an initial retread depth of 0.43 in. and the average tread depth remaining, on the occurrence aircraft's no. 1 tire to be about 65%, no. 2 tire about 90%, and the no. 3 and no. 4 tires, shown above, were in excess of 95% worn.
